# AERFIT – infiltration of rain water by hw-dsi-infiltration

pilot test field in Werder/Germany  
monitoring results 01-06/2023  
-Final Report-

Hölscher Wasserbau GmbH  
Hinterm Busch 23 | 49733 Haren (Ems)

Glindow, 04/08/2023

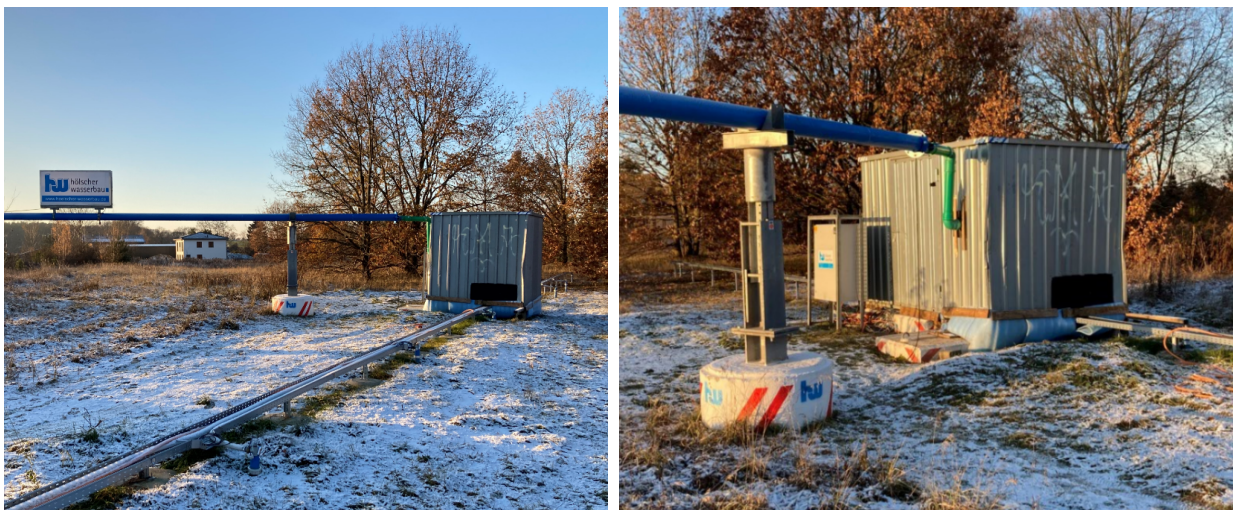
During the frost period a winter protection was installed. An insulation respectively a heating system was necessary for all parts of the plant that were permanently filled with water. Thus, the treatment unit, the magnetic and the mechanical flow meters were enclosed by an insulated walk-in container, equipped with a portable electric heating (Figure 3).

Figure 3 winter protection of the plant

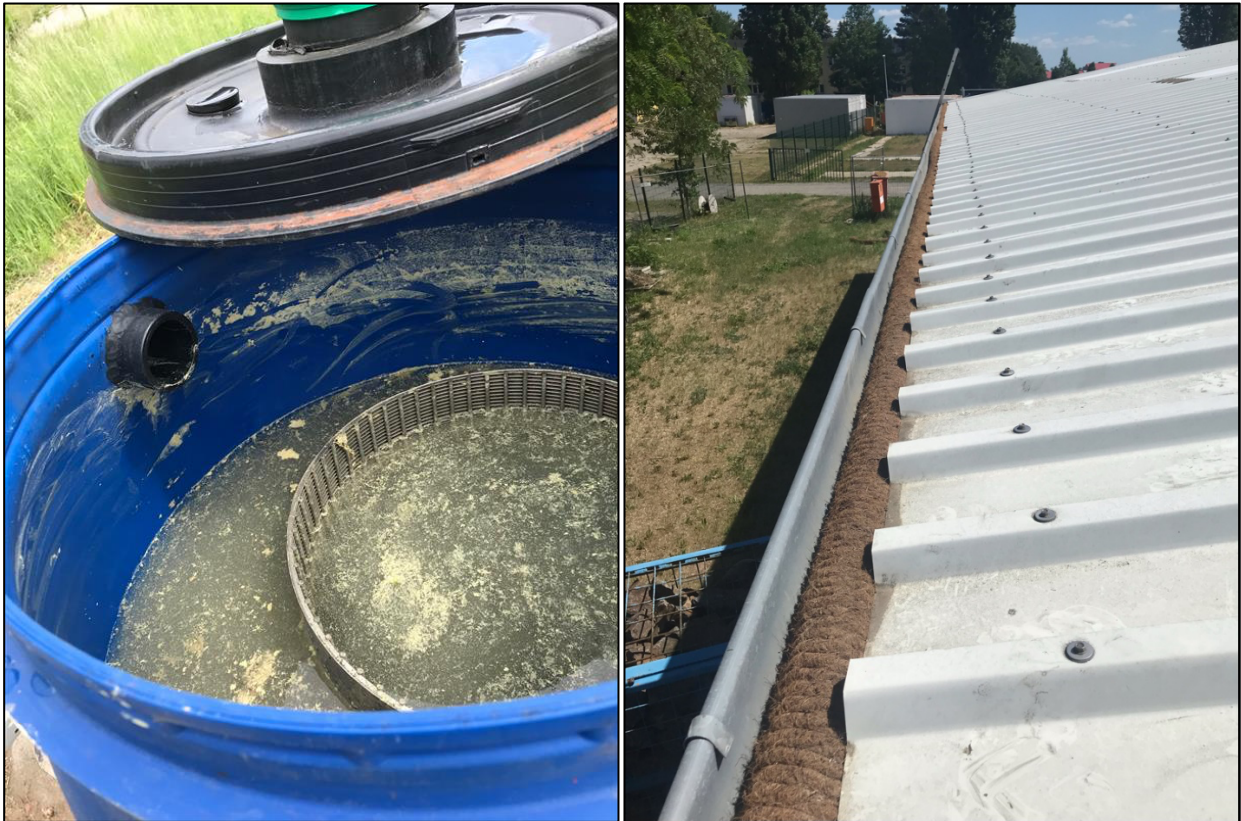
In June 2022 pollen had clogged the treatment unit, so that rain water needed to be diverted temporarily. After the installation of coconut fiber in the gutter of the roof area and adjustments of the water level within the treatment unit, we were curious whether these settings could prevent this problem in the following season. In 2023 however, there was hardly any precipitation during the pollen period of mid-May until mid-June. So results on this issue are still pending.

Figure 4 clogged treatment unit in June 2022 (left), coconut fiber in the gutter (right)

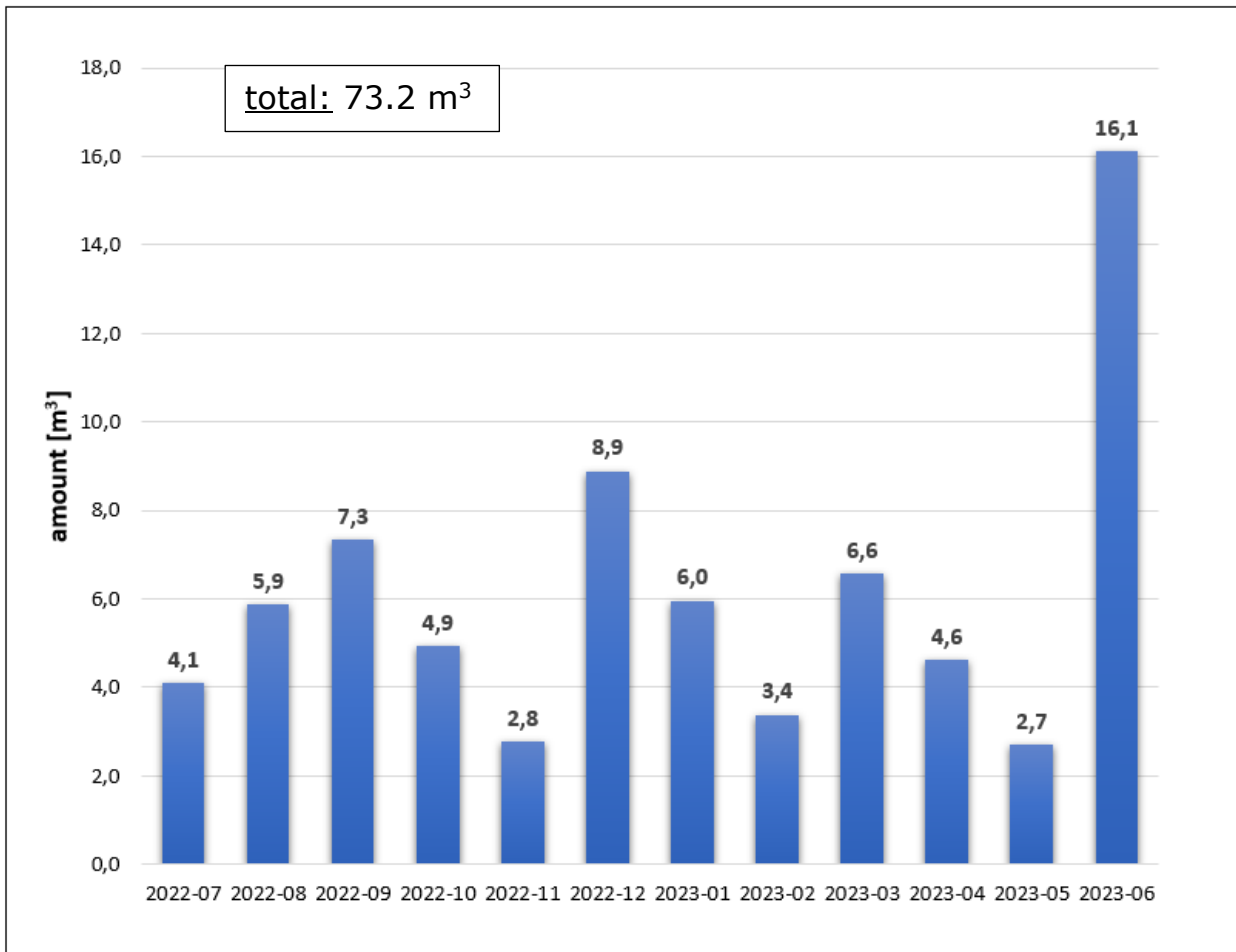
Figure 5 shows the accumulated monthly sums of the data record of the flow meter. The data record of June 2022 is not shown as it represents mainly data of the infiltration test and does not represent actual precipitation data.

In total 73.2 m<sup>3</sup> were infiltrated into the groundwater during the observation period of 1 year. About 20% of the total precipitation fell in June 2023, 11.5 m<sup>3</sup> during one rain event within 24 h hours.

Figure 5 accumulated monthly amounts of infiltrated rainwater

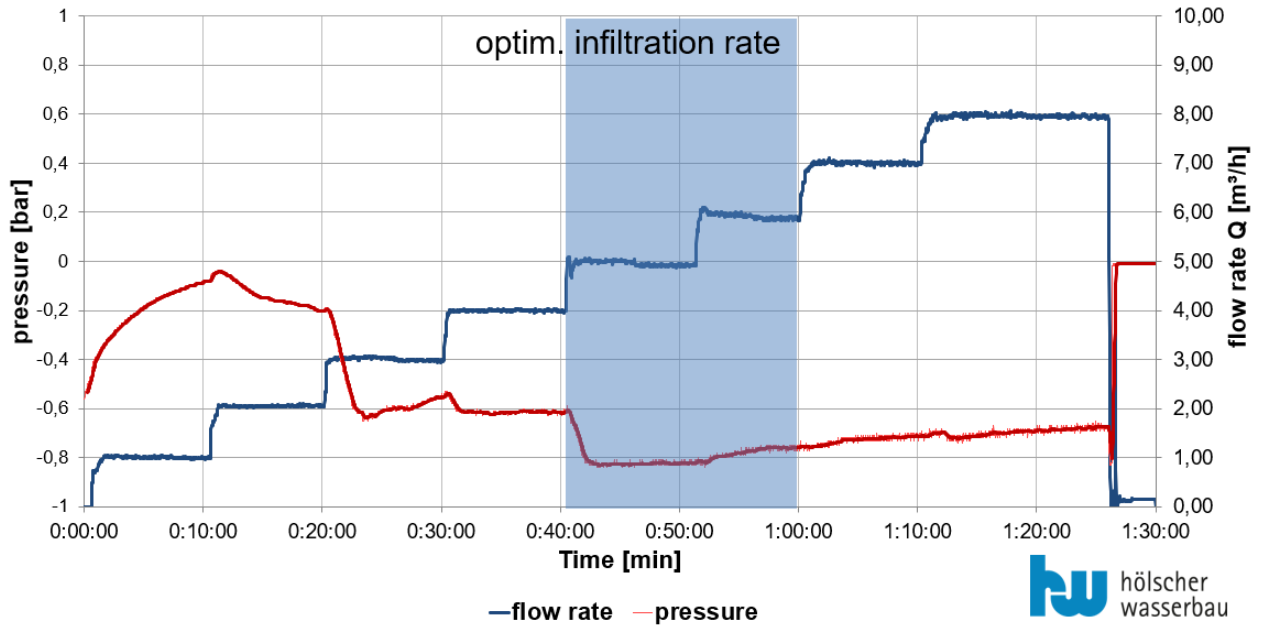
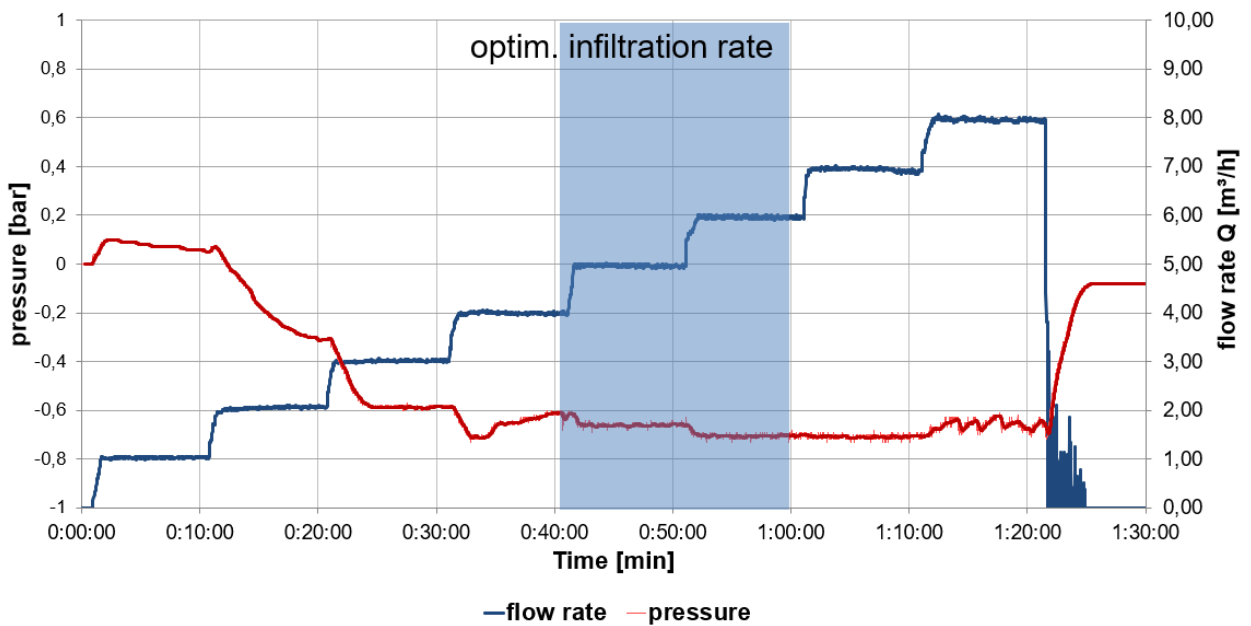
Figure 7 results of the infiltration step test of dsi4 before commissioning of the plant (first diagram) and after one year of infiltration (second diagram)

Comparing the test results of dsi4 (Figure 7), the graphs show nearly the same courses. For each step of the flow rate (blue line), the infiltration pressures (red line) of both campaigns is on nearly the same level. It can be concluded, that rain infiltration as well as longer periods without infiltration have not led to an alteration of the well's infiltration capacity.

The second campaign of the tests was performed on dsi 4 and dsi5. Dsi4 previously showed the highest infiltration capacity of all units: about 4 to 5 m<sup>3</sup>/h. Dsi5 showed a relatively low infiltration capacity of around 0,75 m<sup>3</sup>/h. For an easier comparison, tests were performed with the same infiltration steps than previously.

The results are shown in Figure 7 and Figure 8.

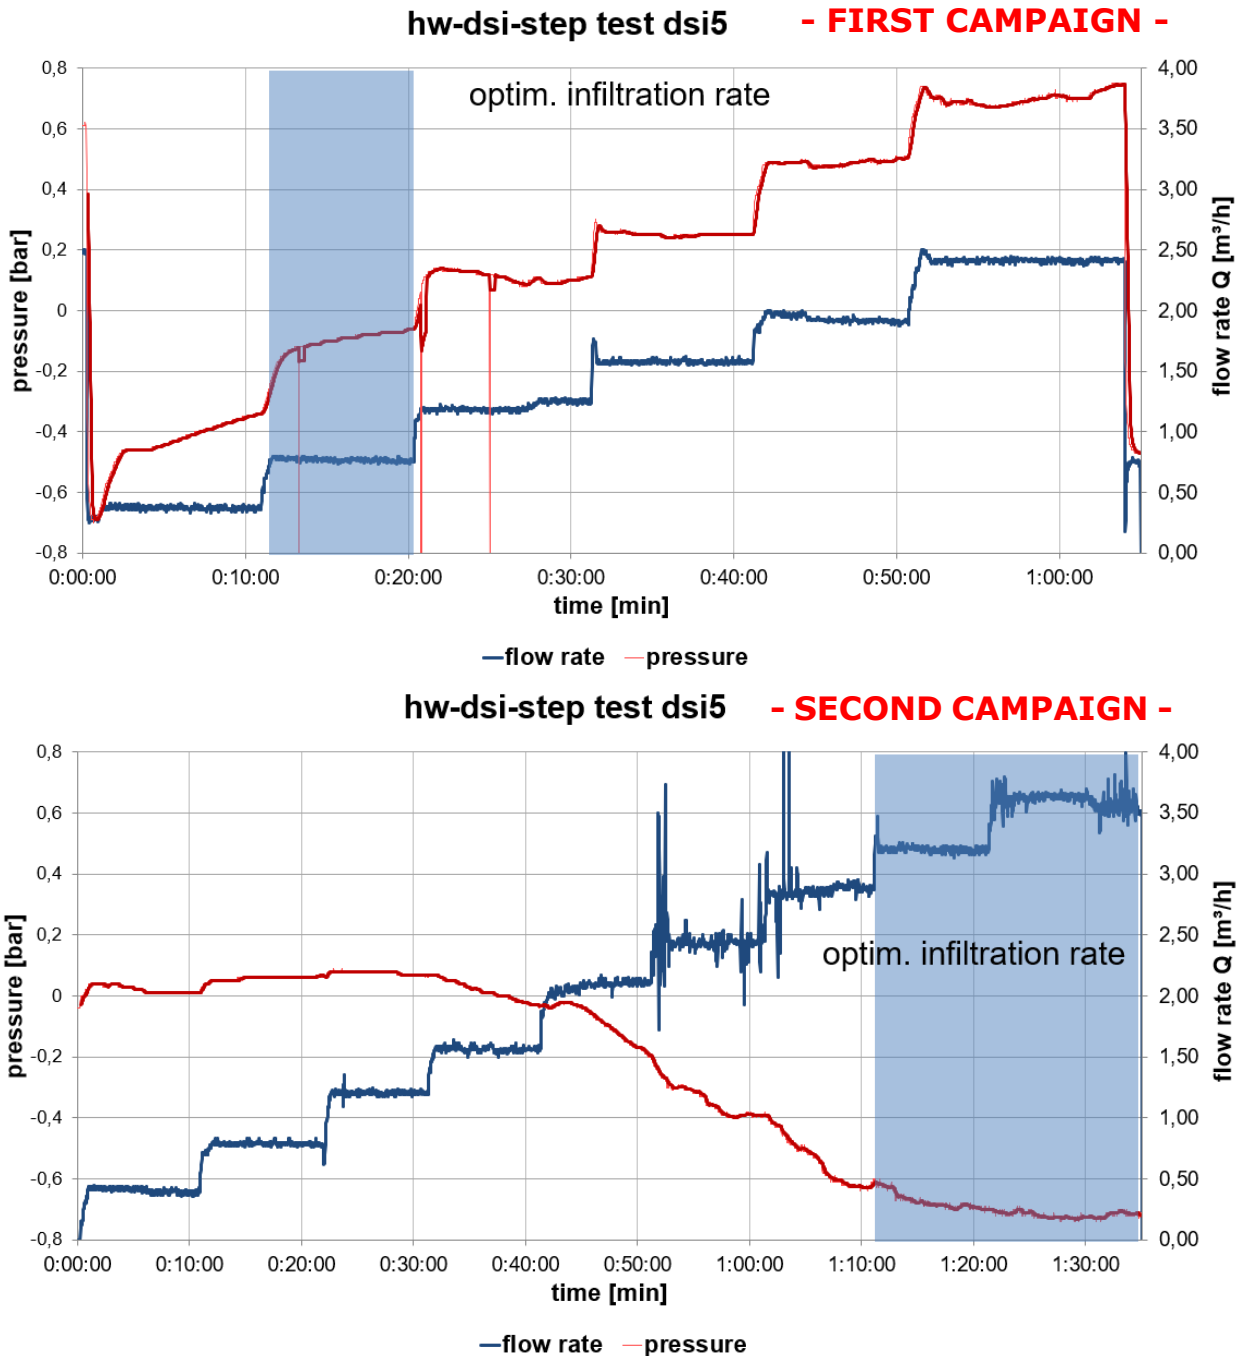
Figure 8 results of the infiltration step test of dsi5 before commissioning of the plant (first diagram) and after one year of infiltration (second diagram)

For dsi5 the results are unexpected at first. Given that fine particles or the growth of algae might clog the infiltration unit, it was expected that infiltration capacities would be reduced after a certain period of operation. However, the test results show, a completely different reaction to infiltration (Figure 8). In the first campaign, pressure (red line) increases with each increase of the flow rate (blue line). Whereas in the second campaign, the course of the pressure appears in a way that is typical for dsi-infiltration in a closed, airless system: with the increase of the infiltration rate the infiltration pressure decreases and reaches a minimum. In this case the minimum pressure was reached at the highest infiltration rate: -0.7 bar at around 3.4 m<sup>3</sup>/h. Taking a closer look at Figure 6 this behavior can be observed during rain water infiltration, too: at the start of the rain period, the water level of dsi5 increases (Figure 6, green line). After some time of constant inflow, the water level jumps down and reaches a level even below resting water level, which can be equaled to a negative pressure within the infiltration unit.

This leads to the question, why this behavior did not occur during the first campaign. Two explanations seem plausible. First, the setup of the test during the first campaign was not ideal. It is possible, that the system (water source, hose connection, standpipe on top of the well and the infiltration unit itself) did not form a closed system, so that water and/or air could enter or run out during the test. Second, it could be possible, that the well itself did not have a good hydraulic connection to the aquifer at the beginning, so that infiltrated water could not be discharged immediately into the groundwater. Long term infiltration "flushed" the filter of the infiltration unit bit by bit.

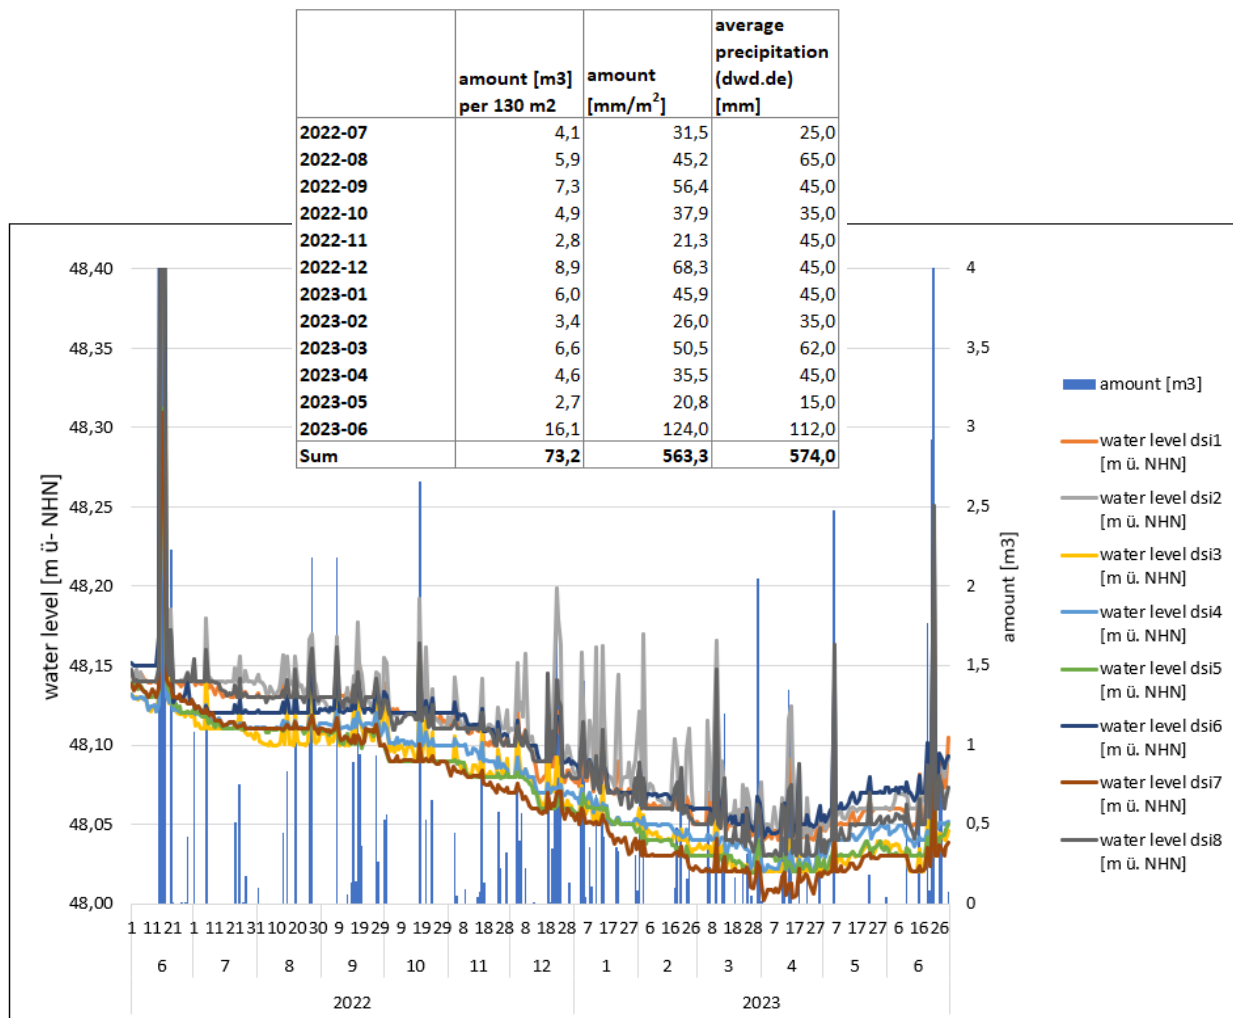
Figure 9 shows the course of groundwater levels and rain events between June 2022 and June 2023 for the site. The table summarizes the measured amounts of rain, that were collected on the 130 m<sup>2</sup> roof area. These amounts were converted to the global unit of precipitation in mm per square meter (middle column). Accordingly, 563 mm/m<sup>2</sup> of precipitation fell during the observation period of 1 year. In comparison, official data from Deutscher Wetterdienst (dwd.de) mentions average precipitation of about 574 mm/m<sup>2</sup> for the region. Thus, the recorded precipitation data ranges within the regional average.

Figure 9 groundwater levels and rain events between June 2022 and June 2023

After a decreasing long-term trend, hydrographs show a slight recovery since April 2023. However, comparing June 2022 and June 2023, ground water levels still range about 10 cm below initial water level. Unfortunately, official monitoring data for the region from a monitoring well about 3 km northwest of the test site was not updated since January 2023
